**REQUEST FOR PROPOSALS (RFP)
for**

Limited Asbestos Abatement and Demolition of 111 Highland, Highland Park, MI 48203

Pre-Demolition Asbestos and Hazardous
Materials Survey
of

111 Highland St.
Highland Park MI 48203

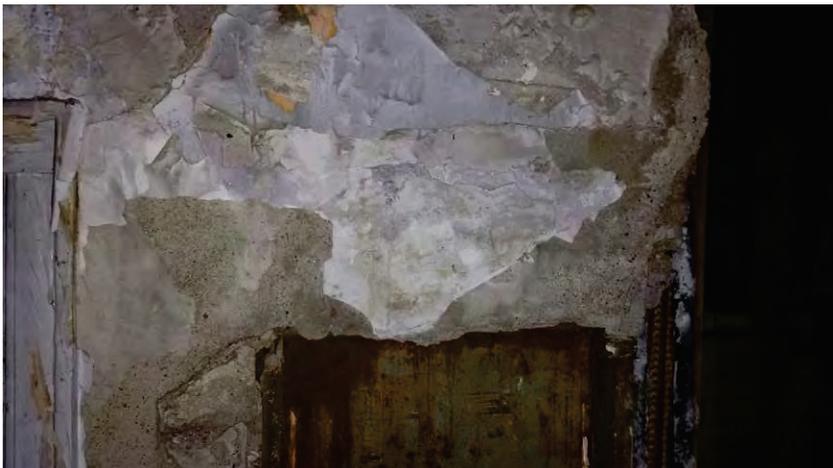
Photograph 2

View of Plaster (HA1)

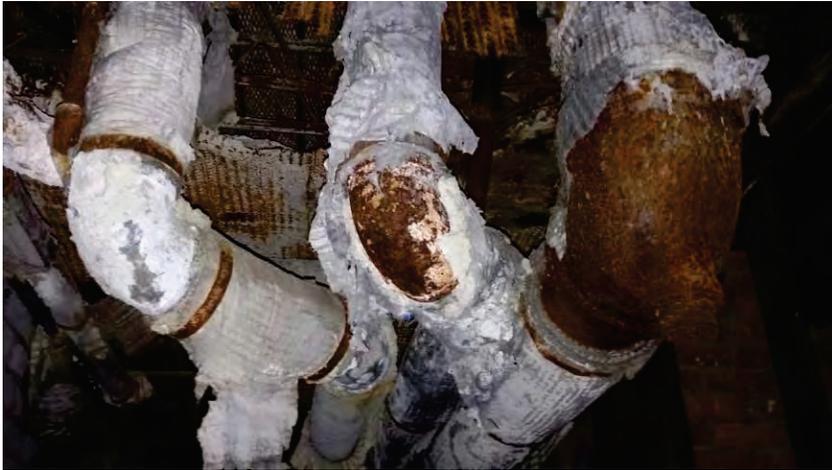
Photograph 3

View of Asbestos-Containing Air Cell
Straight Pipe Insulation and Associated
Fittings (HA2)

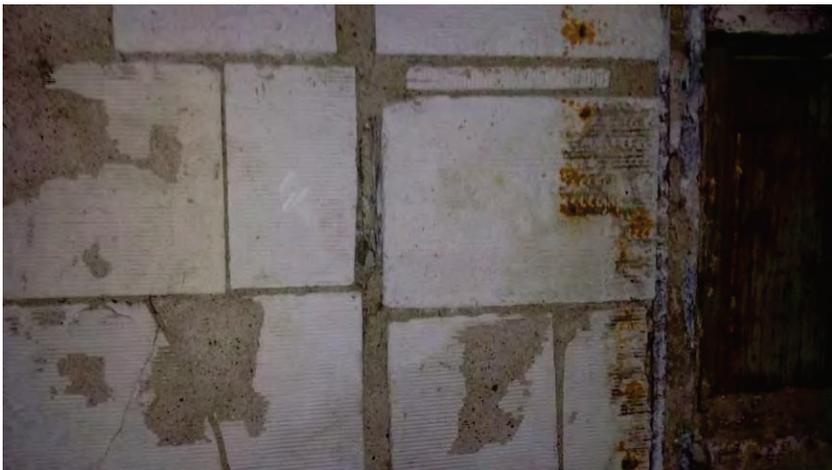
Photograph 4

View of Pyro-Block and Mortar (HA3)

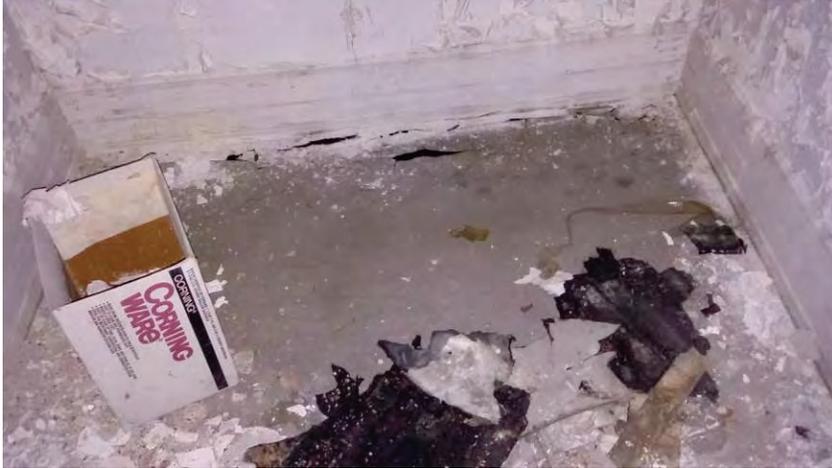
Photograph 5

View of Gray Sheet Flooring and Mastic (HA4)

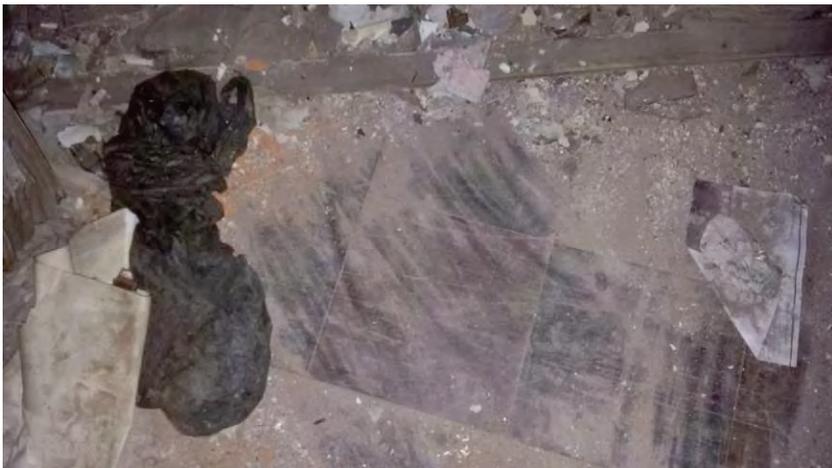
Photograph 6

View of Asbestos-Containing 9" x 9" Floor
Tile and Mastic - Black and Red Intermixed
(HA5)

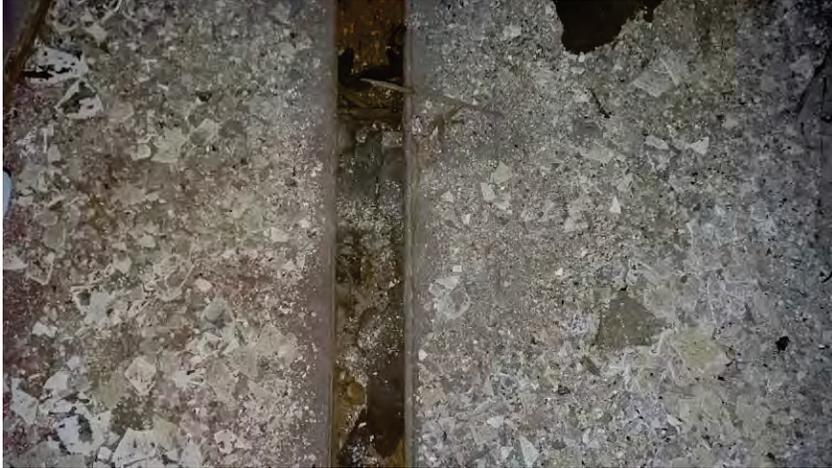
Photograph 7

View of Wood Floor Vapor Barrier (HA6)

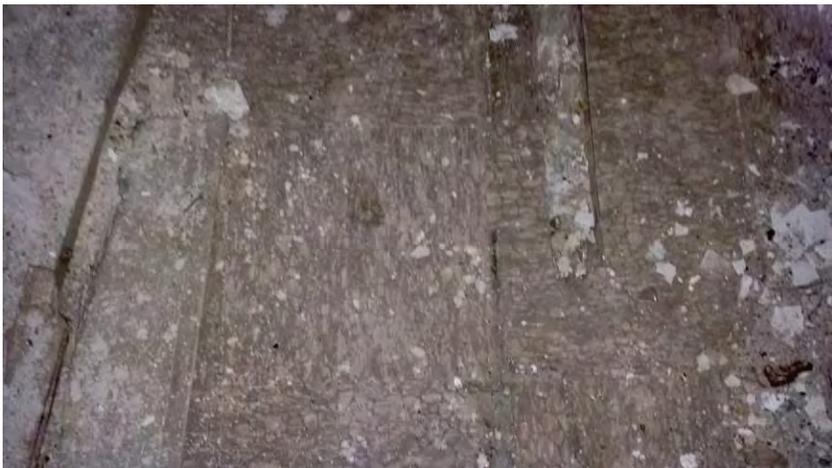
Photograph 8

View of Asbestos-Containing 12" x 12" Floor
Tile and Mastic - Brown Pebble Pattern
(HA7)

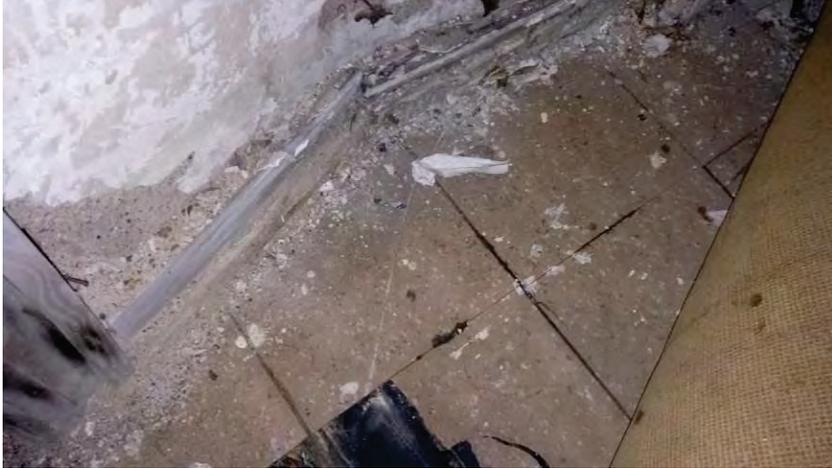
Photograph 9

**View of Asbestos-Containing 9" x 9" Floor
Tile and Mastic - Tan with Light Tan Specks
(HA8)**

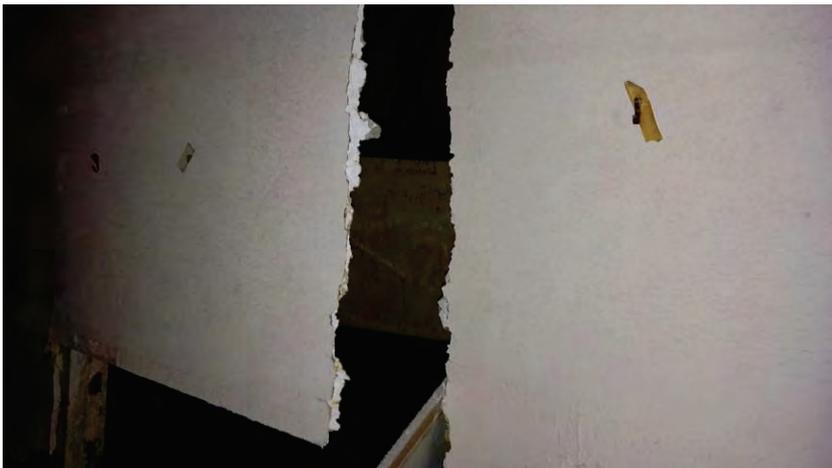
Photograph 10

**View of Asbestos-Containing Drywall and
Joint Compound (HA9)**

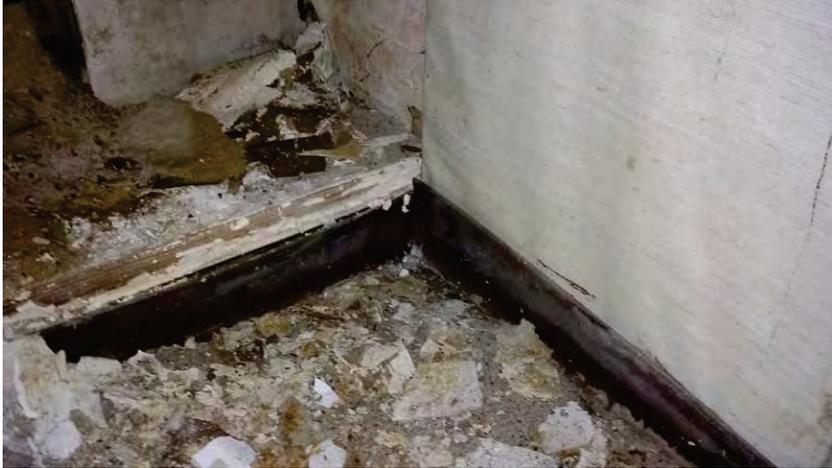
Photograph 11

View of Brown Cove Base and Adhesive
(HA10)

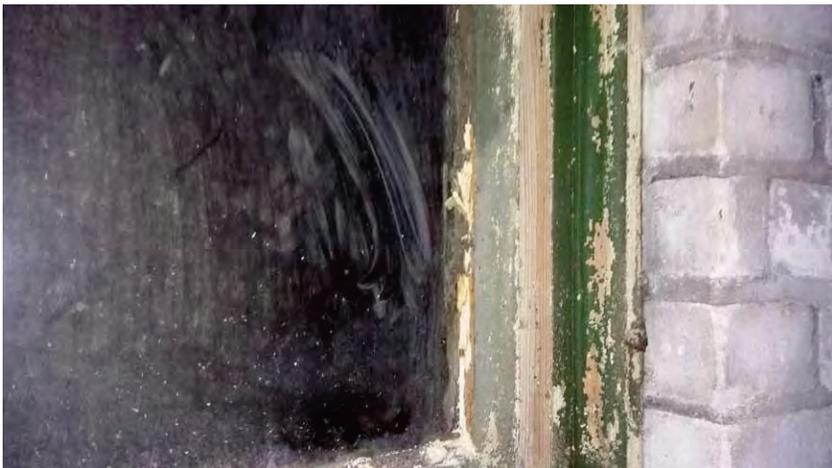
Photograph 12

View of Interior Window Glazing (HA11)

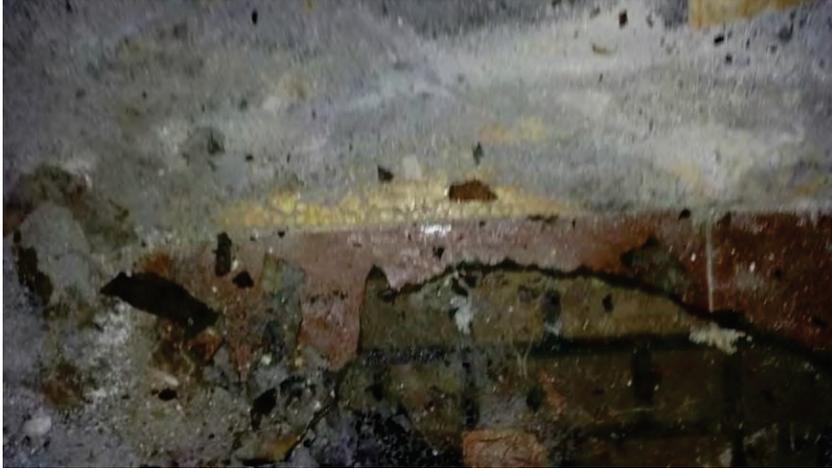
Photograph 13

View of Asbestos-Containing Multi-Layered Sheet Flooring - Basement - Second most SE Room (HA12)

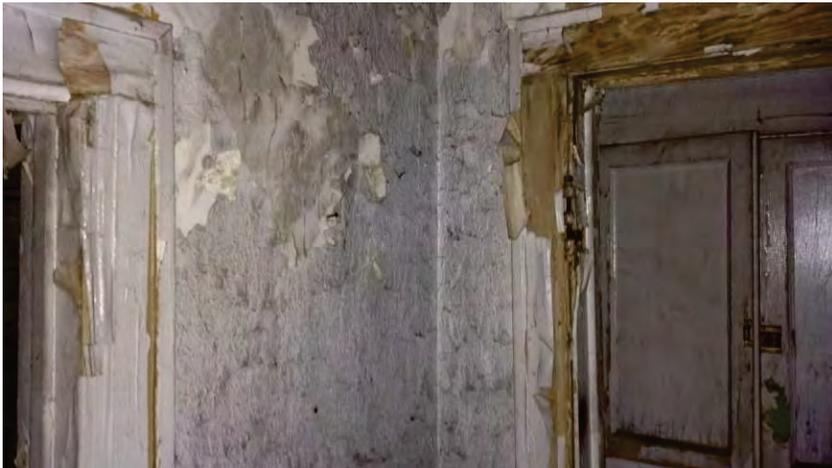
Photograph 14

View of Asbestos-Containing Wall and Ceiling Texture (HA13)

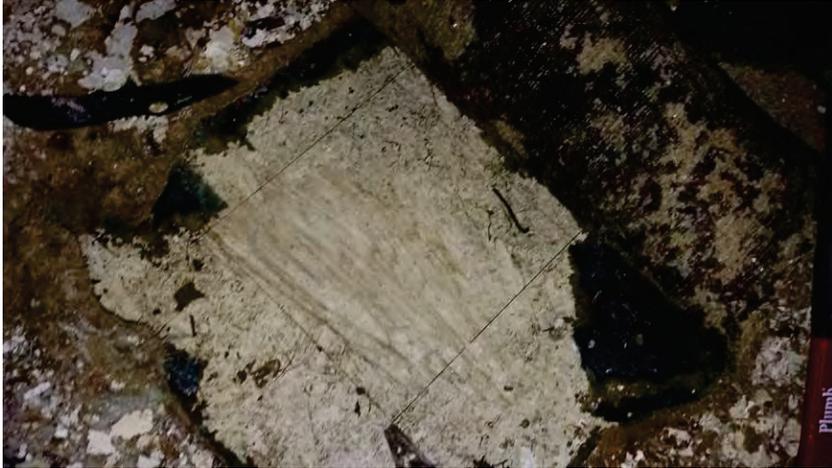
Photograph 15

View of Asbestos-Containing 12" x 12" Floor
Tile and Mastic - Light Tan (HA14)

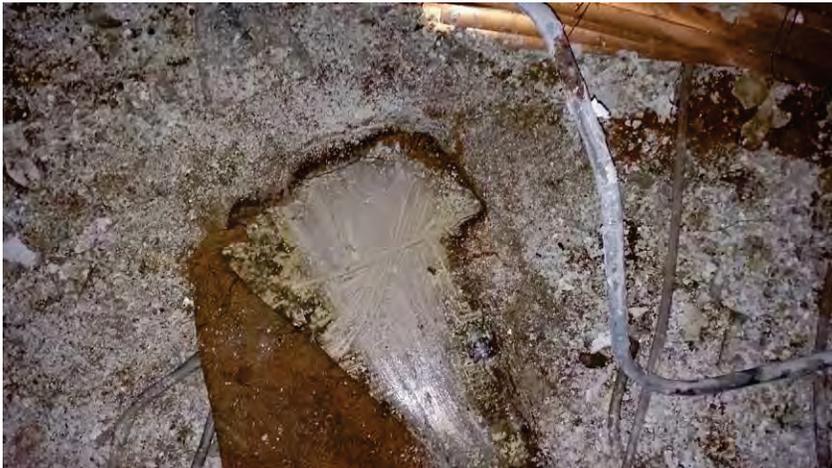
Photograph 16

View of Asbestos-Containing 9" x 9" Floor
Tile and Mastic - Light Tan (HA15)

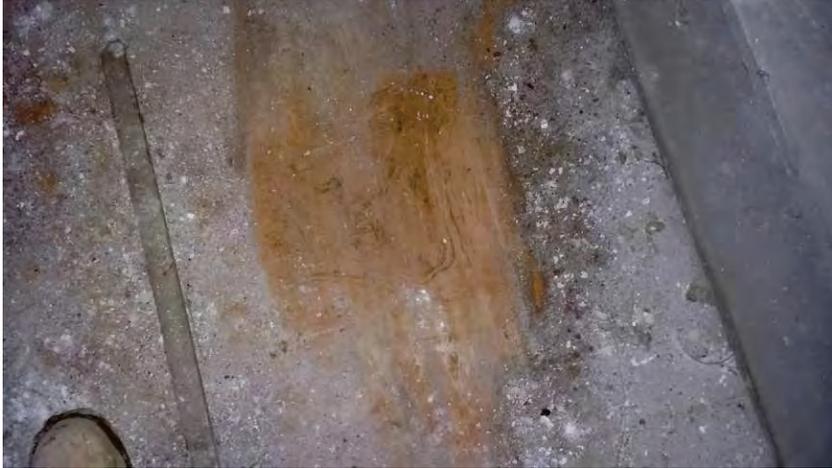
Photograph 17

**View of Asbestos-Containing 9" x 9" Floor
Tile and Mastic - Orange Marbled (HA16)**

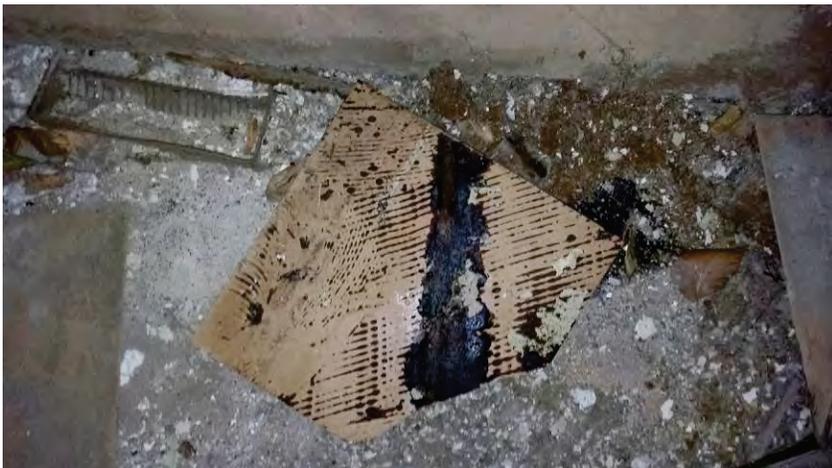
Photograph 18

**View of Asbestos-Containing 9" x 9" Floor
Tile and Mastic - Tan with Cream Streaks
(HA17)**

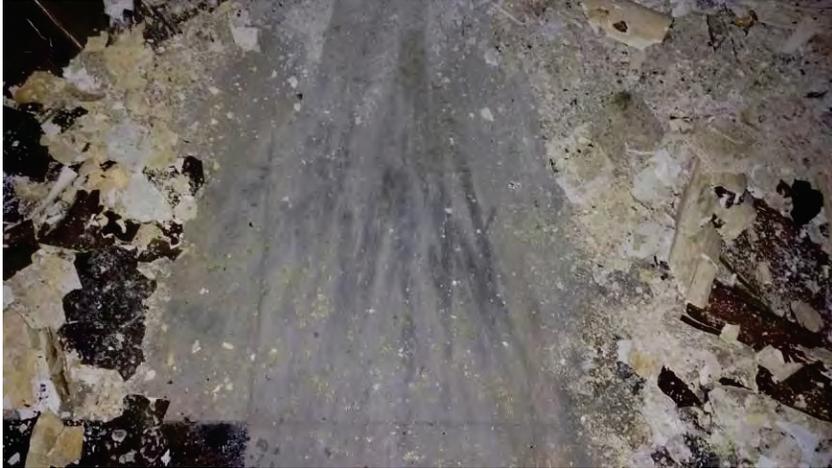
Photograph 19

View of Asbestos-Containing 9" x 9" Floor
Tile and Mastic - Black with Gold Flake
Pattern (HA18)

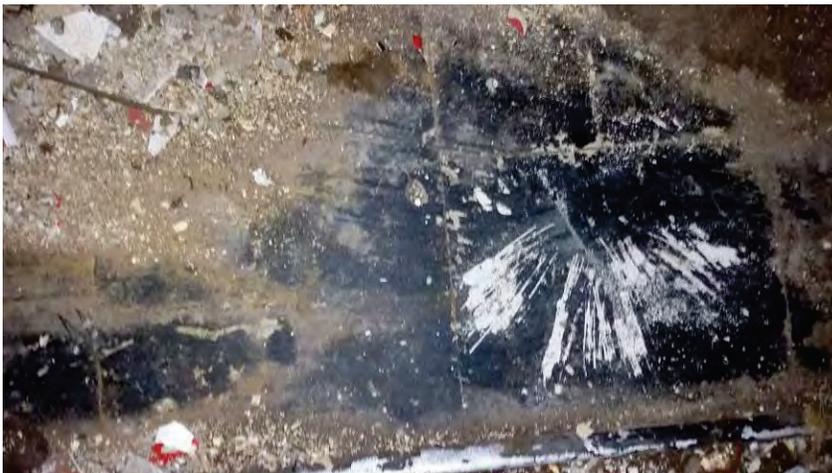
Photograph 22

View of Asbestos-Containing Residual
Mastic (HA21)

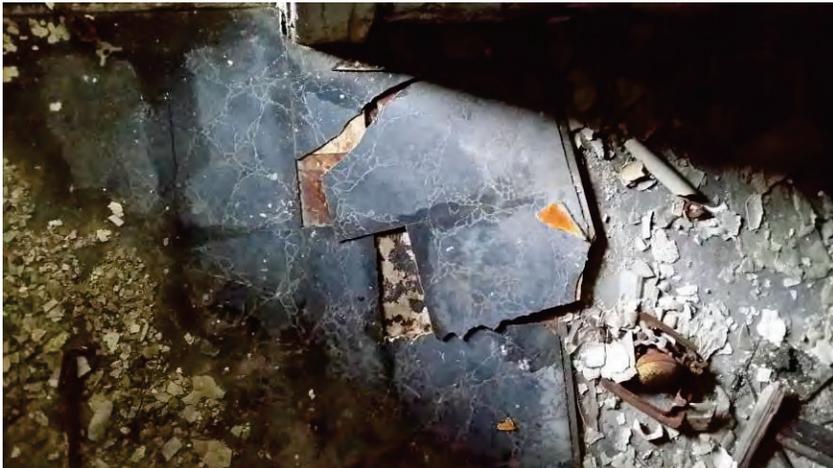
Photograph 26

View of Asbestos-Containing Multi-Layered Kitchen Flooring and Mastic - Room Adjacent E to S Stairwell (HA25)

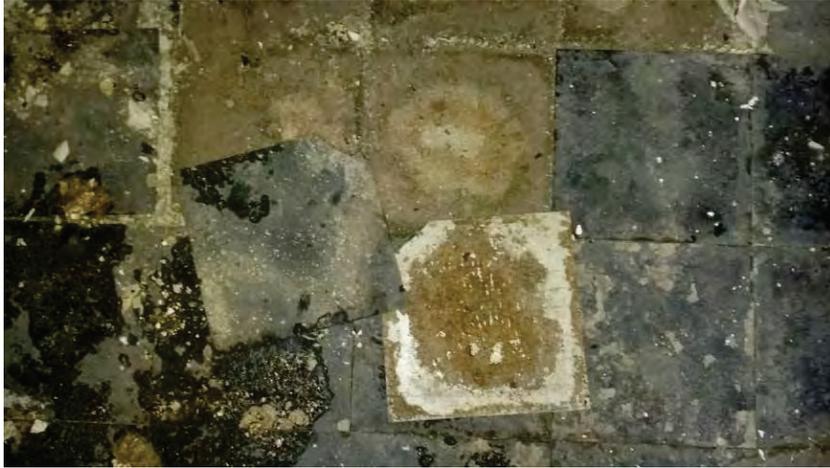
Photograph 29

**View of Asbestos-Containing 9" x 9" Floor
Tile and Mastic - White and Black Intermixed
(HA28)**

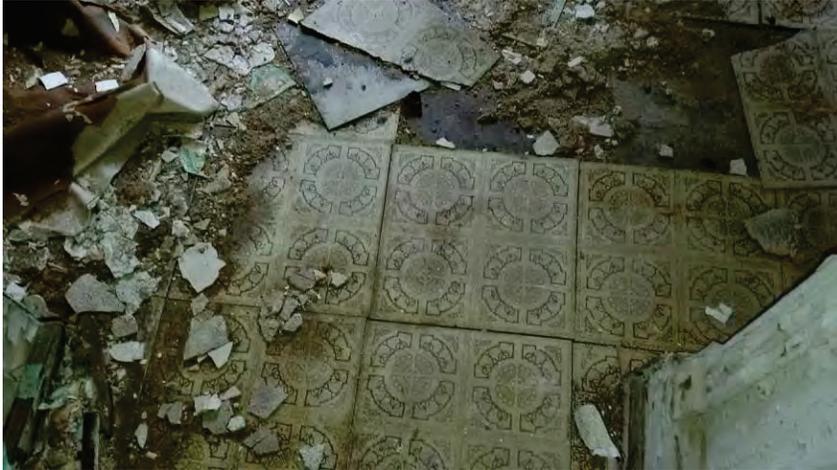
Photograph 31

**View of Asbestos-Containing 12" x 12" Floor
Tile and Mastic - Tan with Cross Pattern
(HA30)**

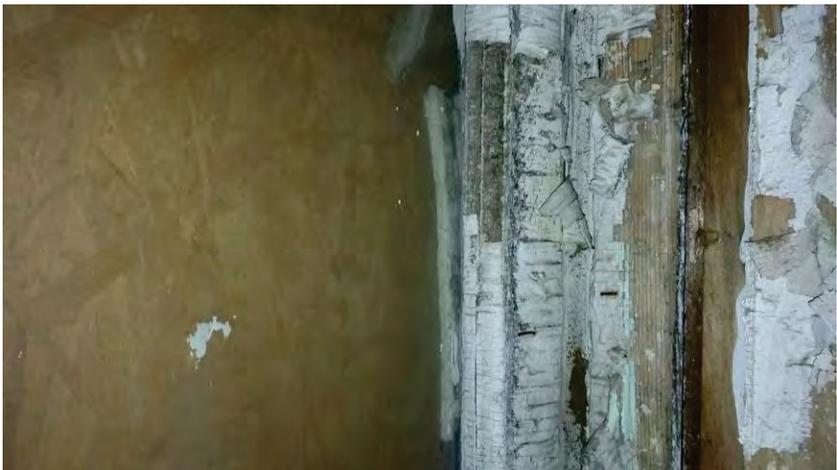
Photograph 32

**View of Asbestos-Containing Exterior
Window Glazing (HA31)**

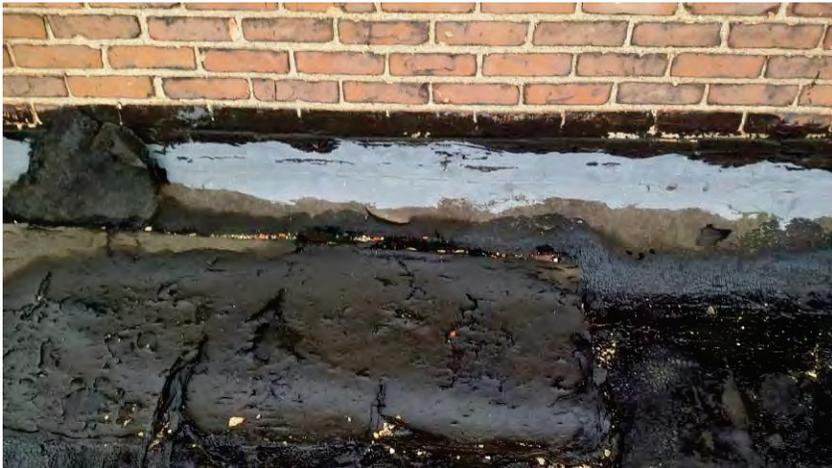
Photograph 36

View of Asbestos-Containing Black Roof Flashing (HA35)

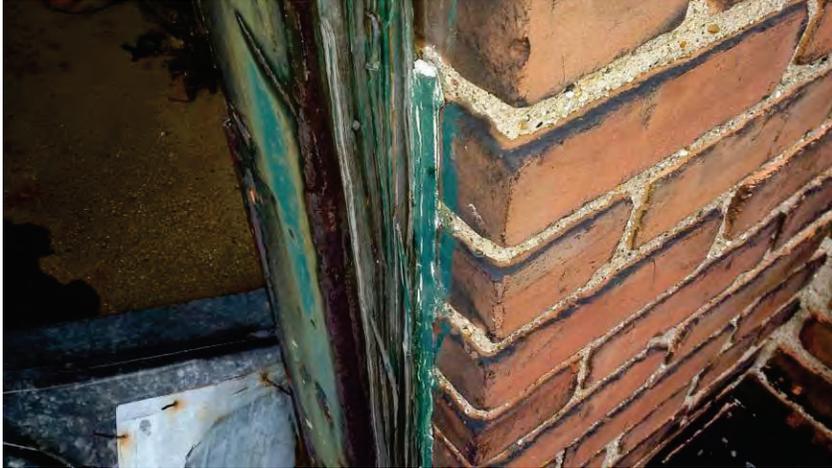
Photograph 37

View of Asbestos-Containing Exterior Door
Caulk - White (HA36)

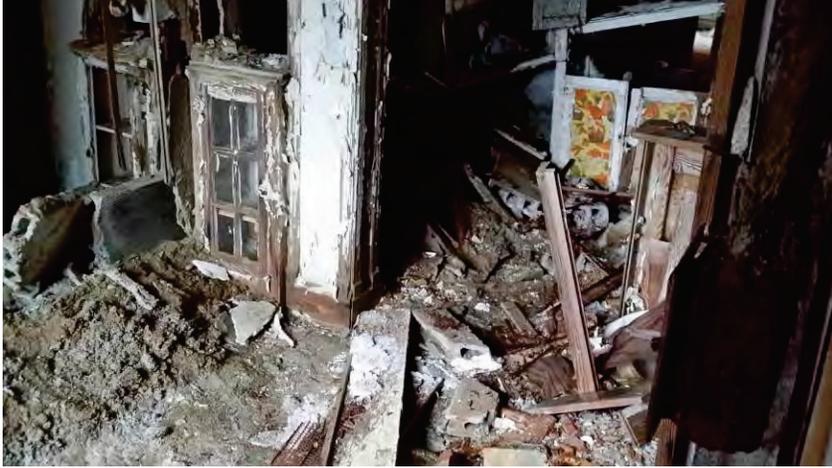
Photograph 39

View of a Typical Inaccessible Kitchen

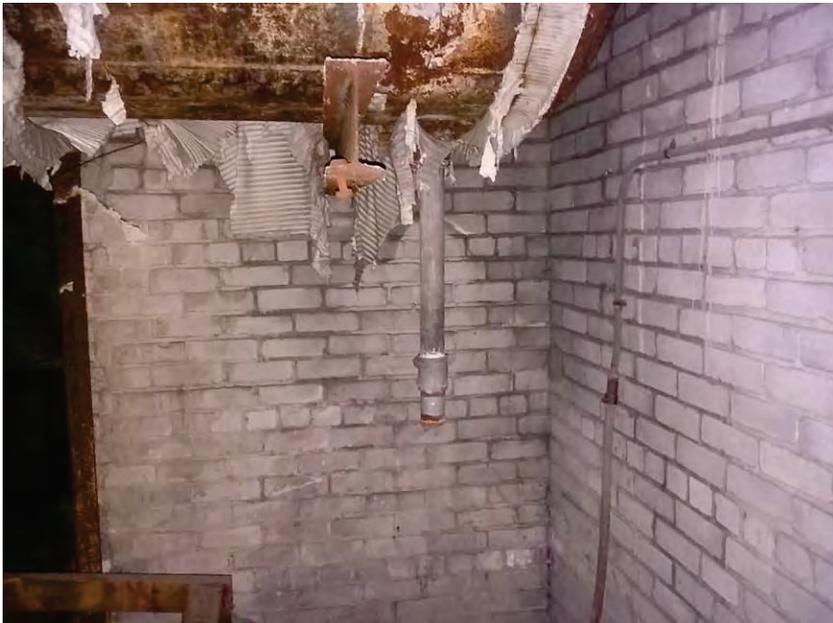
Photograph 52

View Empty AST in Basement (Note: Vertical pipe beneath tank was open, verifying tank is empty)
