**REQUEST FOR PROPOSALS (RFP)
for**

Limited Asbestos Abatement and Demolition of 111 Highland, Highland Park, MI 48203

Pre-Demolition Asbestos and Hazardous
Materials Survey
of

111 Highland St.
Highland Park MI 48203

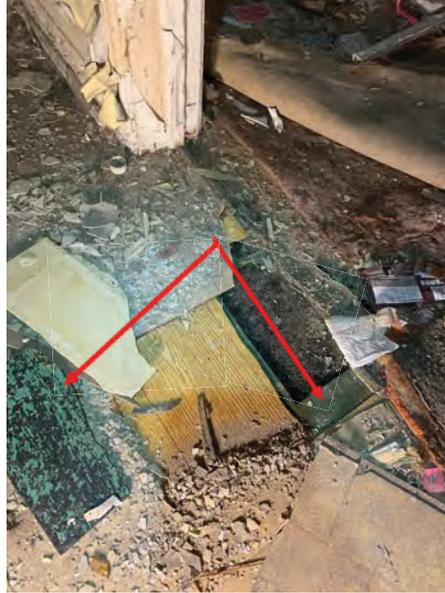
**Asbestos-Containing HM# 9 – 9”x9” Floor Tile
(Green) w/ Mastic**

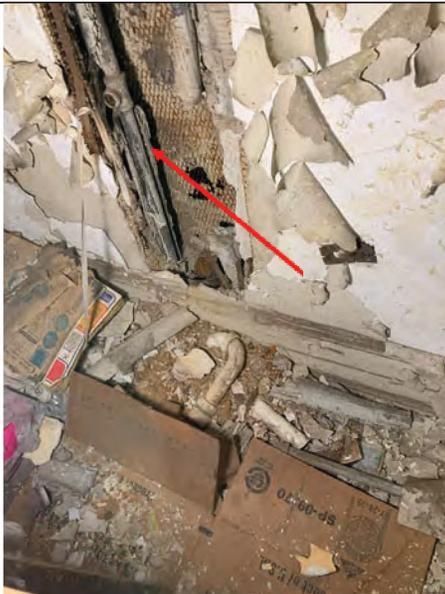
10A-B	Construction Adhesive (Beige)	FS 8	NF	Poor	NAD	NA	NA	NA
11A-C	<2" Straight Pip Insulation (Grey/White)	All Bathrooms and Kitchens in Units FS 6 8, 10, 71, 74, 76, 78, 81, 82, 86, 87, 88, 89, 195	F	Poor	40% Ch	RACM	Class I	Visually Observed 385 LF, & ~ 6,024 LF (in chases/walls/cavities/etc.)

**Asbestos-Containing HM# 11 – Straight Pipe
Insulation (<2” – Grey/White)**

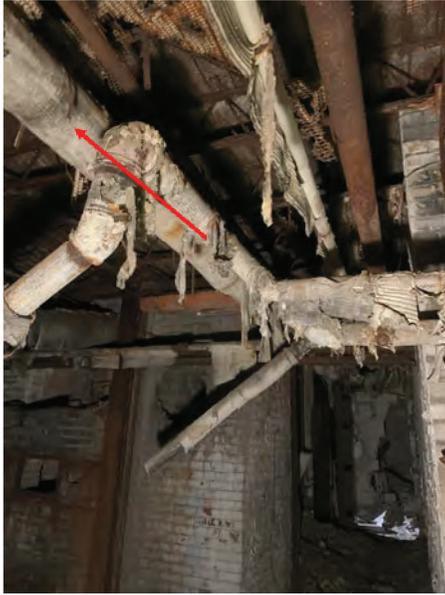
**Asbestos-Containing HM #31 ->6" Stright Pipe
Insulation (White)**

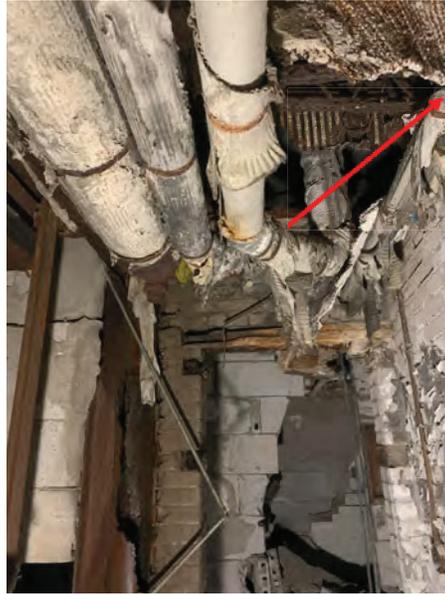
**Asbestos-Containing HM #32 -<2" Pipe Joint
Insulation (White)**

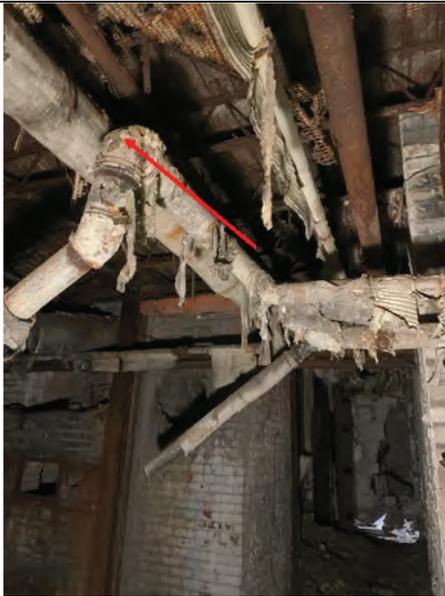
**Asbestos-Containing HM #33 -4" Pipe Joint
Insulation (White)**

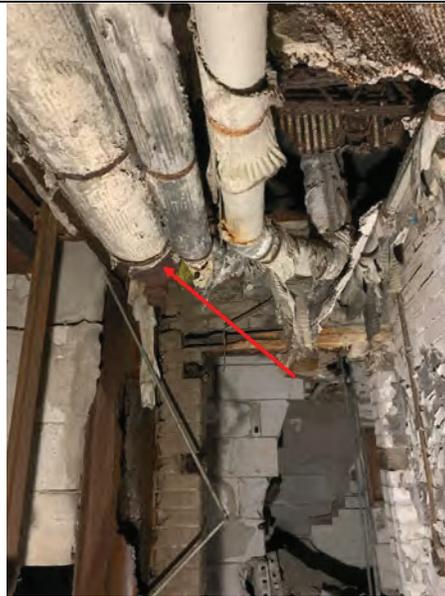
**Asbestos-Containing HM #34 ->6" Pipe Joint
Insulation (White)**

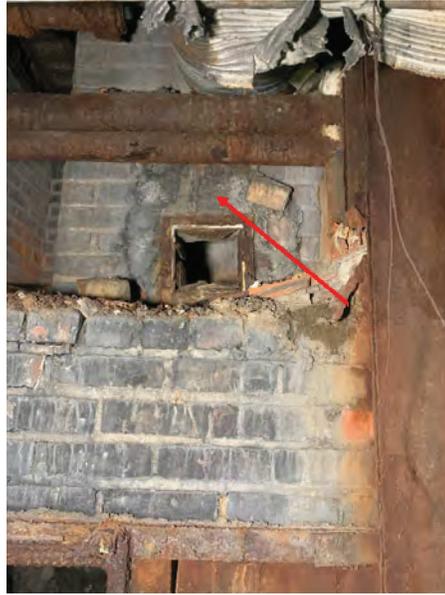
**Asbestos-Containing HM #36 – Cement Patch
(Grey)**

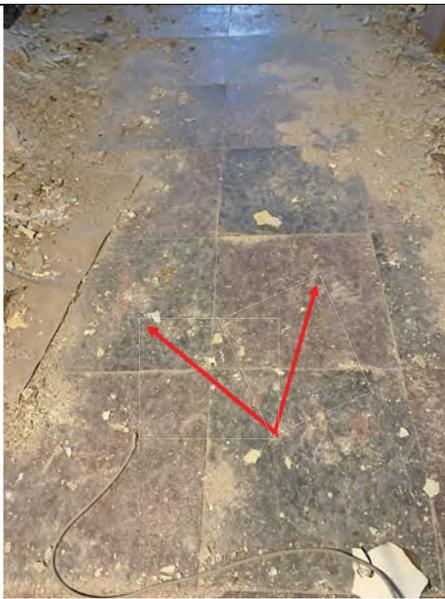
**Asbestos-Containing HM #37 – 9”x9” Floor Tile
(Black & Brown) w/ Mastic**

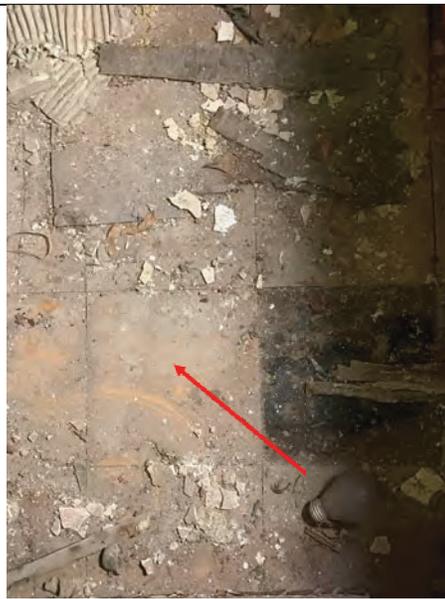
**Asbestos-Containing HM #38 – 9”x9” Floor Tile
(Beige) w/ Mastic**

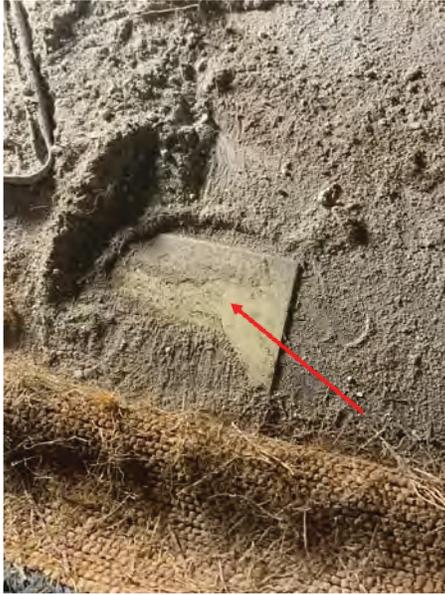
**Asbestos-Containing HM #39 – 9”x9” Floor Tile
(Cream) w/ Mastic**

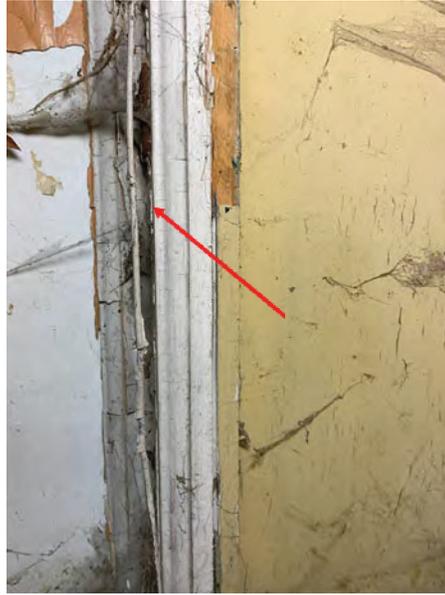
**Asbestos-Containing HM #40 – Exterior Window
Glaze**

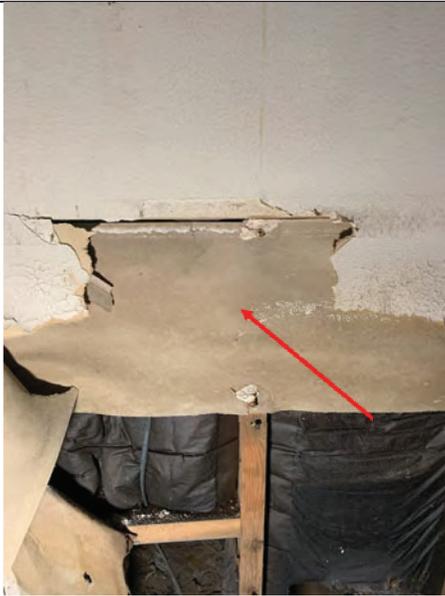
**Asbestos-Containing HM# 41 – Drywall & Joint
Compound (Tan/White)**

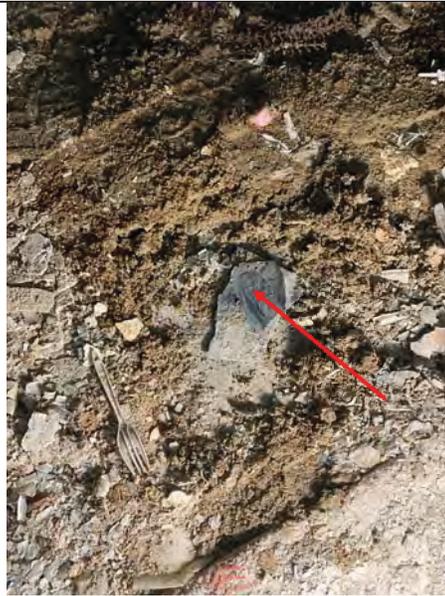
**Asbestos-Containing HM #42 – 9”x9” Floor Tile
(Black) w/ Mastic**

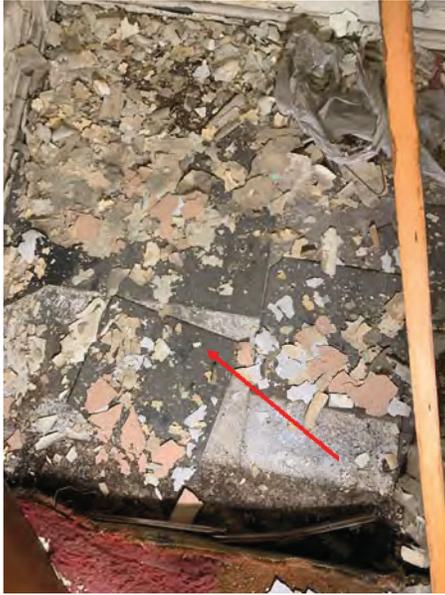
**Asbestos-Containing HM #49 – 9”x9” Floor Tile
(White & Brown - Mottled) w/ Mastic**

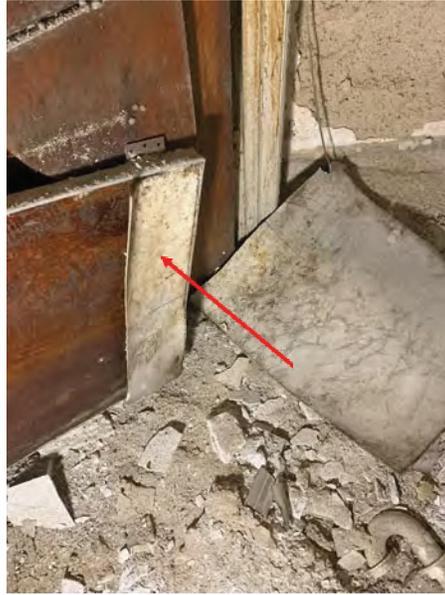
**Asbestos-Containing HM #53 – Countertop
Sheeting (White)**

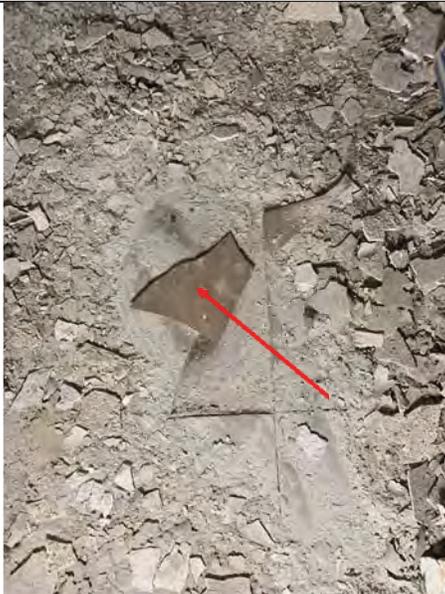
**Asbestos-Containing HM #54 – 9”x9” Floor Tile
(Light Brown) w/ Mastic**

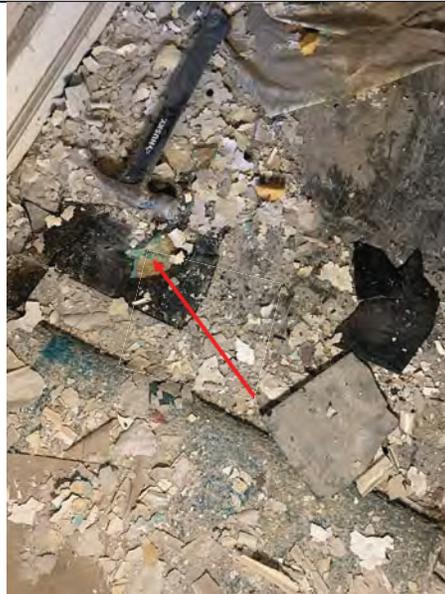
**Asbestos-Containing HM #55 – 9”x9” Floor Tile
(Top – Black) w/ Mastic & Green Floor Tile w/
Mastic**

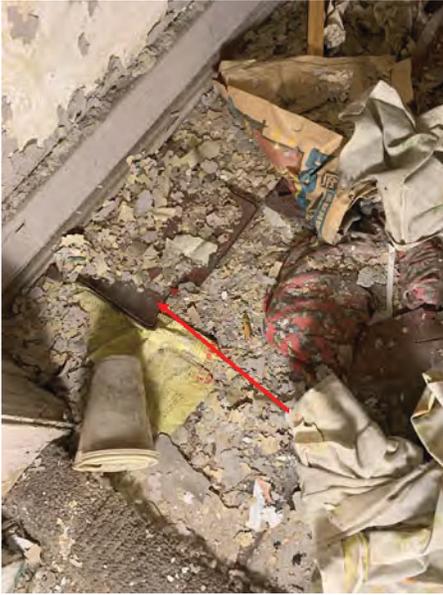
**Asbestos-Containing HM #56 – 9”x9” Floor Tile
(Top - Red) w/ Floor Sheet/Felt**

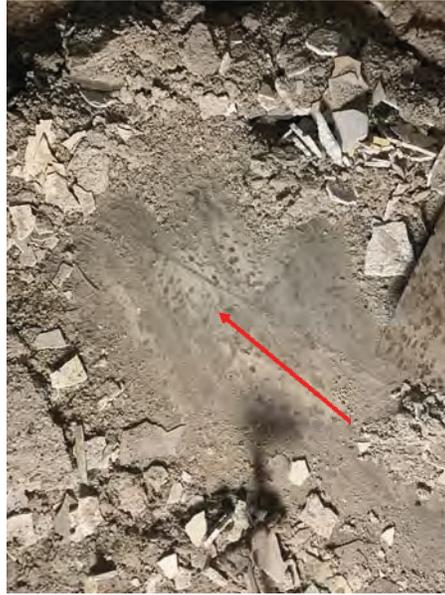
**Asbestos-Containing HM #59 – 9”x9” Floor Tile
(Tan w/ Gold Specks) w/ Mastic**

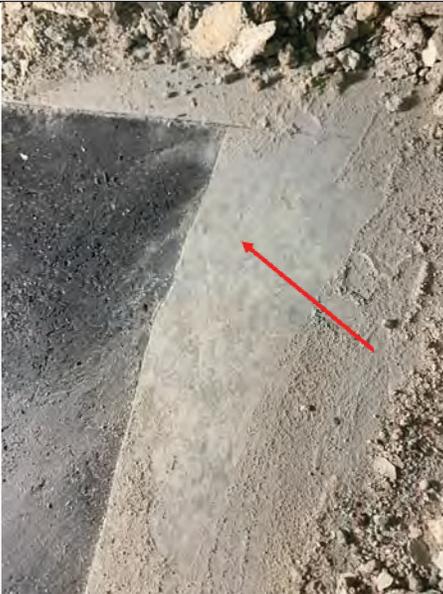
**Asbestos-Containing HM #60 – 9”x9” Floor Tile
(Tan w/ Green) w/ Mastic**

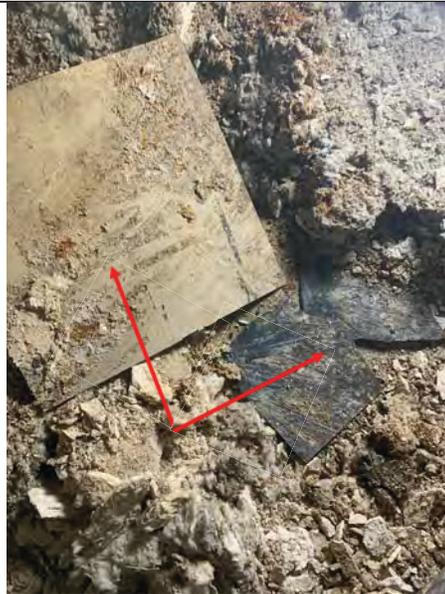
**Asbestos-Containing HM #61 – 9”x9” Floor Tile
(Black) w/ Glue & 9”x9” Floor Tile (Tan) w/ Glue**

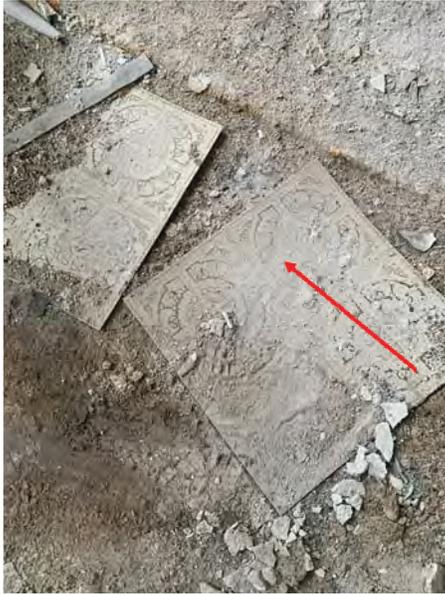
Asbestos-Containing HM #66 – 12”x12” Floor Tile (Cream – Patterned) w/ Mastic

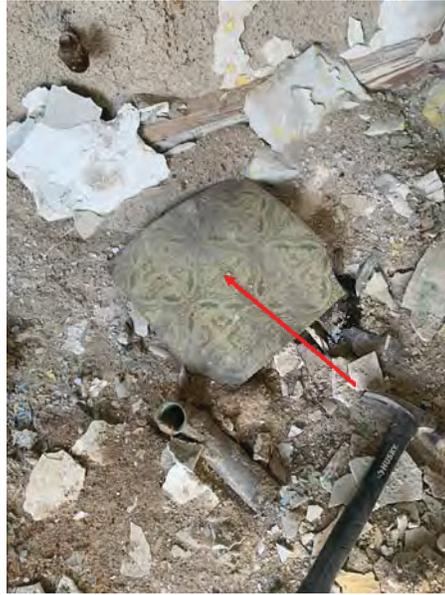
Asbestos-Containing HM #67 – 12”x12” Floor Tile (Top – Green - Patterned) w/ Glue & Beige Floor Tile w/ Glue & Sheet Floor/Felt

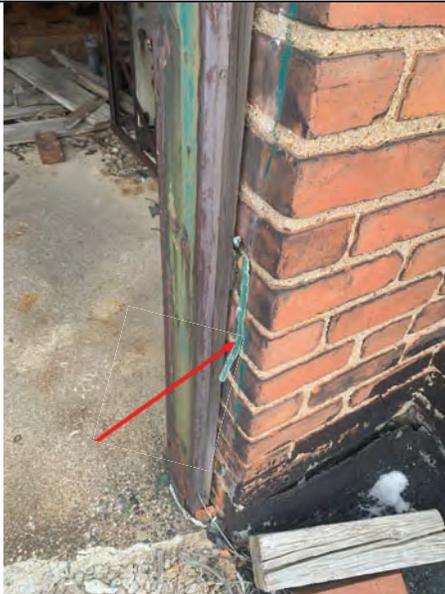
Asbestos-Containing HM #70 – Exterior Door/Window Frame Caulk (Tan – Painted Green)

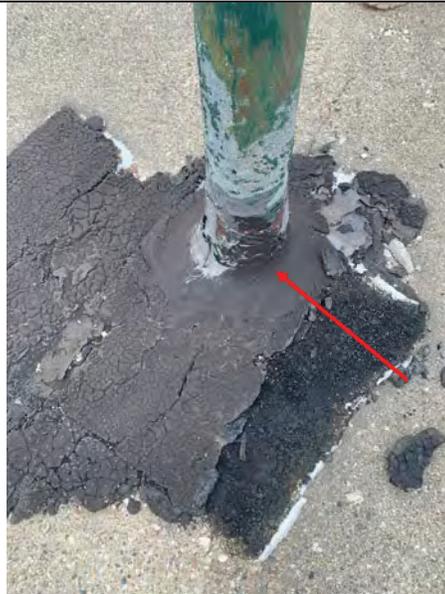
Asbestos-Containing HM #71 – Roof Flashing (Black)

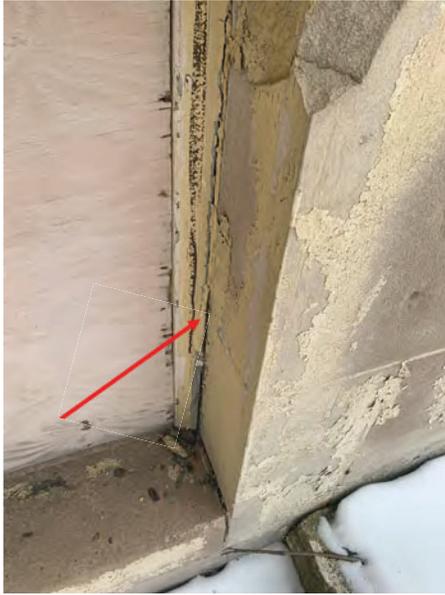
**Asbestos-Containing HM #72 – Exterior Caulk
(Brown – Painted Cream)**

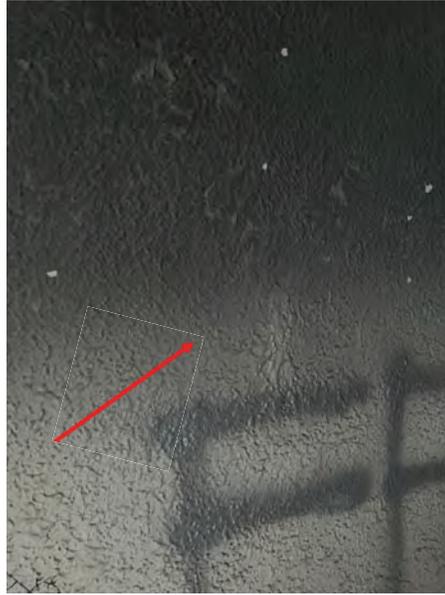
**Asbestos-Containing Textured Wall & Ceiling
Application (White)**

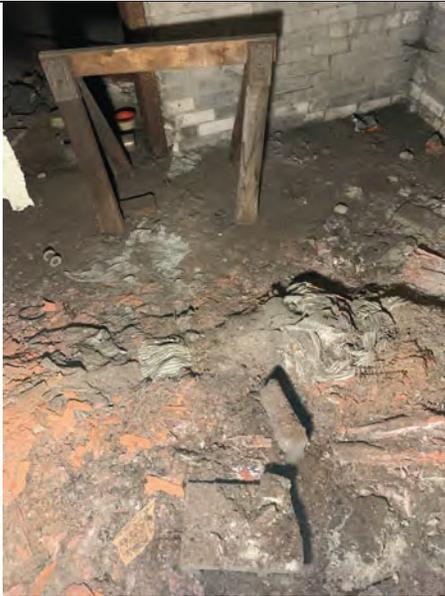
- General building conditions were very poor. Plaster, pyro brick, lead-based paint, asbestos-containing textured wall/ceiling application, and asbestos-containing thermal system insulation littered the floors all throughout the building. In a lot of cases, entire functional spaces were inaccessible due to excessive debris and/or poor structural integrity. Building integrity was a concern during the survey. Several parts throughout the building had standing water/ice and there were parts of the floor missing in some of the functional spaces. There was also a lot of human trash piled up, blocking stairways and other functional spaces. TEC made their best efforts to thoroughly inspect all areas of the building. If new materials are discovered during demolition, they should be treated as asbestos-containing or tested to prove asbestos content.

**Debris Contaminated w/ Asbestos-Containing
Material**

Prior to demolition, TEC recommends that the identified ACMs (assumed and verified by sampling), as well as the assumed hazardous materials, be removed prior to demolition. Category I Non-Friable (such as the assumed roofing material) ACM may often be left in place during demolition if not made friable by cutting, grinding or sanding. If left in place, these materials cannot be recycled or used as clean fill.

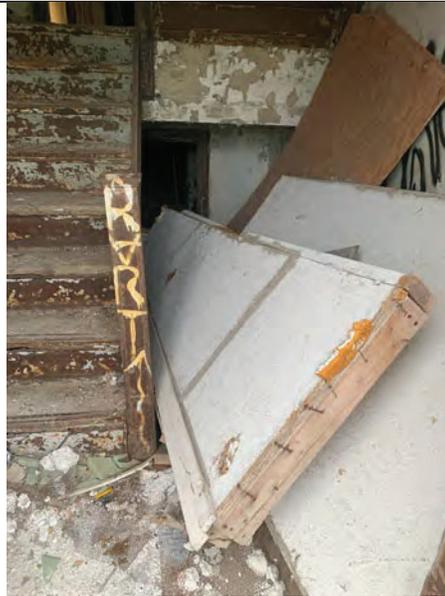
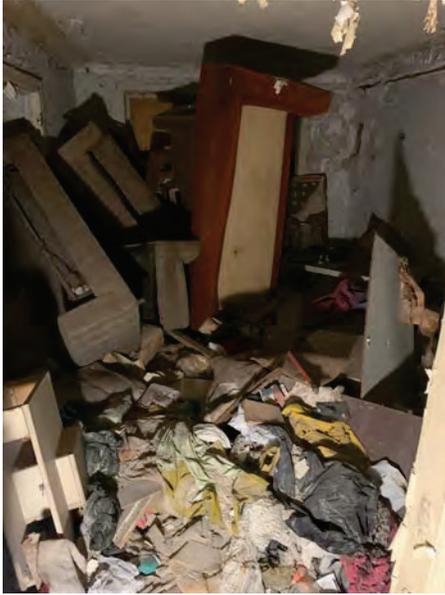
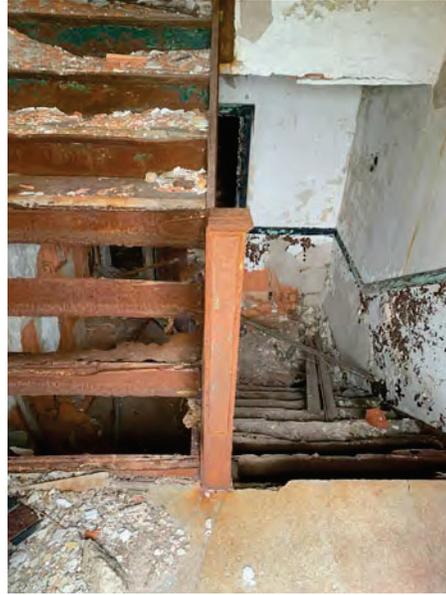
- **The following areas were inaccessible due to excessive debris, building condition, and/or structural integrity:** Functional Space 135, 137, 153, 154, 156, 166, 179, 180, 195, 198, 199(closet), 208(closet), 244(closet), 245, 246, 253(both closets), 262, 264, 271, 274, 275(closet), 279(closet), 284(kitchen), 286, 287, 288, 289, 290, 292(closet), 301(closet), 304(kitchen), 308(Both Closets), 309, 310, 311, 312, 313, 314, 315, 316, 317, 324, 325, 330(kitchen), 335(kitchen), 336, 344(closet), 351, 352, 353, 354, 355, 357(kitchen), 358(kitchen), 363, 367, 372(closet), 374, 375, 376, 377, 378, 379, 380, 381, 383, 385, (hallway), 388(closet), 389, 390, 391, 392, 396(kitchen), 398(closet), 400(kitchen), 401, 406(kitchen), 407(kitchen), 409, 414(kitchen), 416, 417, 418, 419, 420, 421, 422, 423(kitchen), 432, 434(kitchen), 439, 440, 441, 443, 444, 445, 446, 448, 449, 456 (See Appendix G for specific locations)

General Building Pictures of Inaccessibility

Any areas that were noted as being inaccessible during this assessment or any concealed areas, such as behind walls, where suspect ACMs could be discovered, will require a survey for ACM.

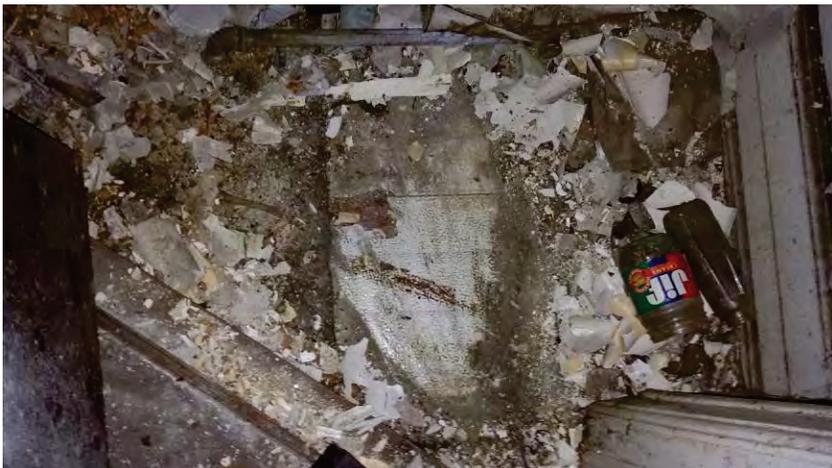
Photograph 20

View of 12" x 12" Floor Tile and Mastic - Tan
Brick Pattern (HA19)

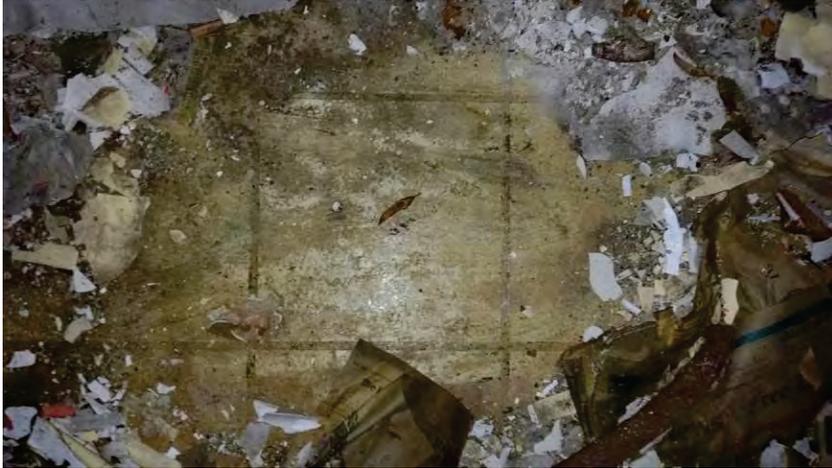
Photograph 21

View of Sheet Flooring and Mastic - Tan 9"
Square Pattern (HA20)

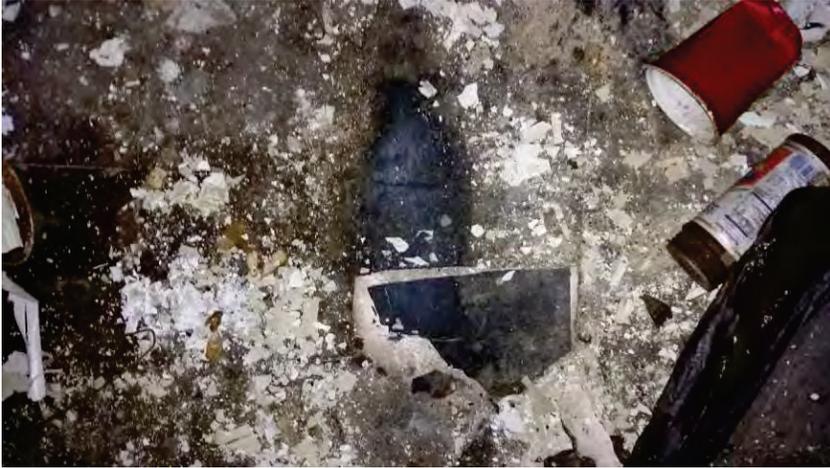
Photograph 23

View of 9" x 9" Floor Tile and Mastic - All Black
(HA22)

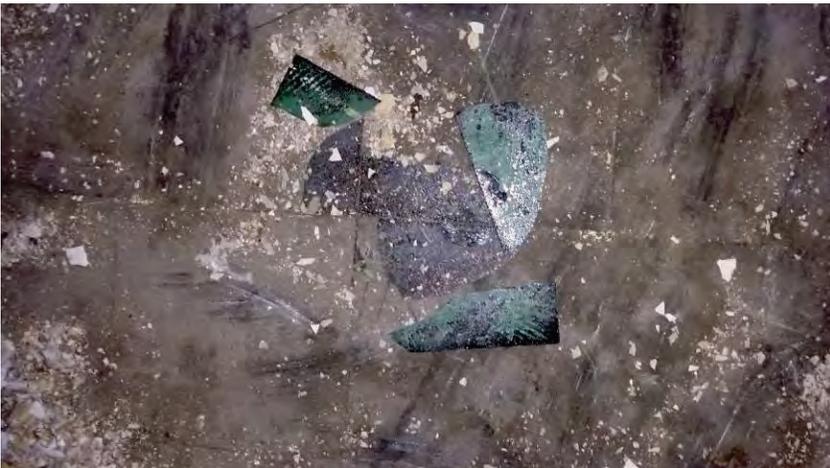
Photograph 24

View of Asbestos-Containing 9" x 9" Floor
Tile and Mastic - Green with White Streaks
(HA23)

Due to the severe deterioration of building components that are present throughout the building, it is recommended that all identified materials and associated debris should be removed and disposed of as ACM. This will also be necessary to access asbestos-containing flooring and/or mastics found under debris piles.

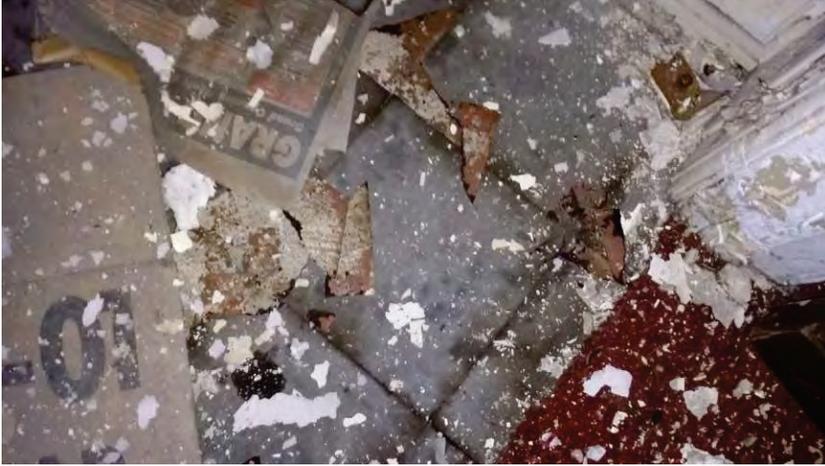
Photograph 25

View of 9" x 9" Floor Tile and Mastic - All Red (HA24)

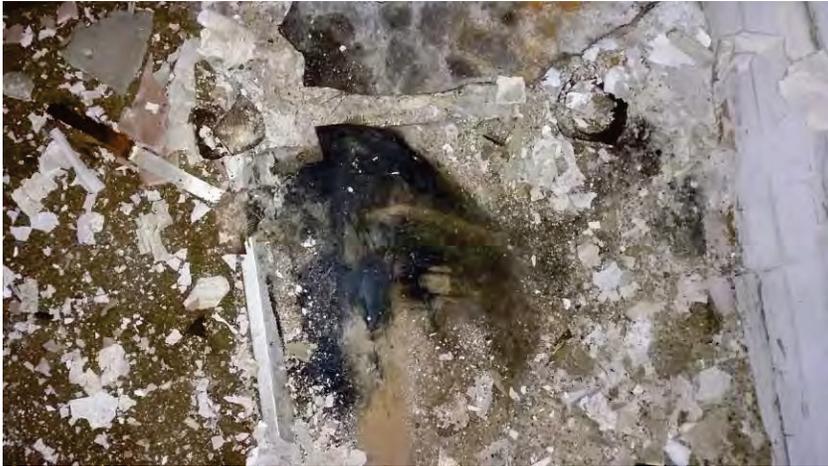
Photograph 27

View of Black Sheet Flooring and Mastic
(HA26)

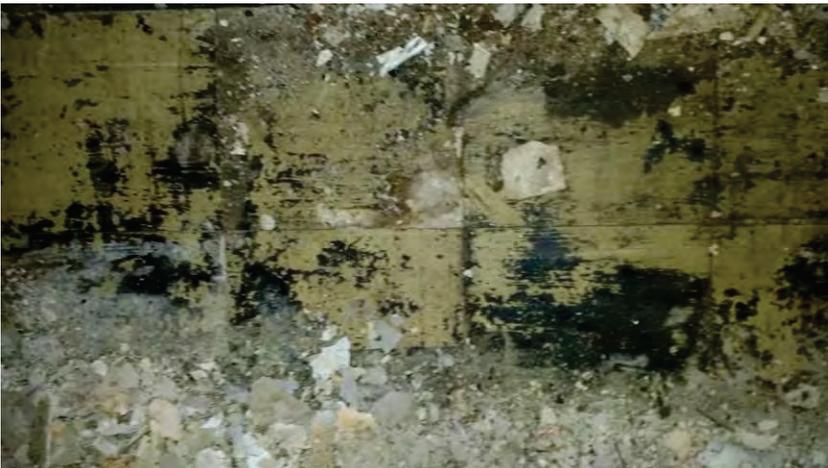
Photograph 28

HA No.	Homogeneous Area Description	Asbestos Content
18	9" x 9" Floor Tile and Mastic - Black with Gold Flake Pattern	Floor Tile: 3% Chrysotile, Mastic: None Detected
19	12" x 12" Floor Tile and Mastic - Tan Brick Pattern	None Detected
20	Sheet Flooring and Mastic - Tan 9" Square Pattern	None Detected
21	Residual Mastic	2% Chrysotile
22	9" x 9" Floor Tile and Mastic - All Black	Floor Tile: 3% Chrysotile, Mastic: None Detected
23	9" x 9" Floor Tile and Mastic - Green with White Streaks	Floor Tile: 4% Chrysotile, Mastic: None Detected
24	9" x 9" Floor Tile and Mastic - All Red	None Detected
25	Multi-Layered Kitchen Flooring and Mastic - Room Adjacent SE to NW Stairwell	Black/Brown Sheet Flooring: None Detected, Brown/Black Sheet Flooring: None Detected, Floor Tile: 3% Chrysotile, Adhesive: None Detected
26	Black Sheet Flooring and Mastic	None Detected
27	9" x 9" Floor Tile and Mastic - Yellow	Floor Tile: 2% Chrysotile, Mastic: None Detected

View of Asbestos-Containing 9" x 9" Floor
Tile and Mastic - Yellow (HA27)

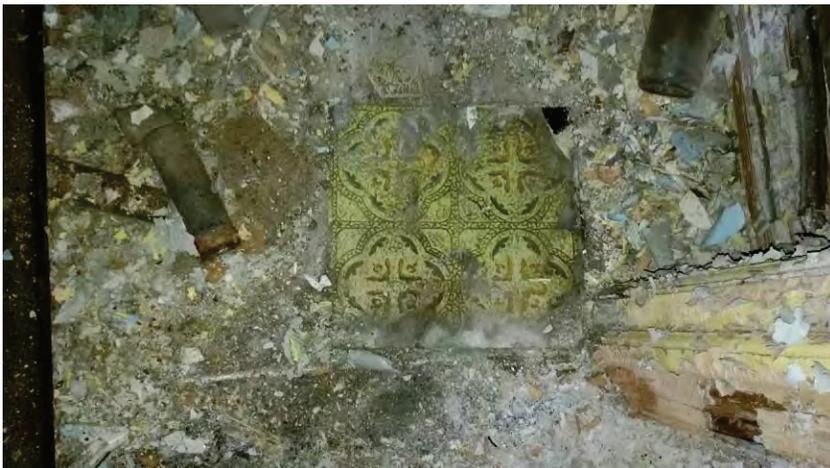
Photograph 30

**View of Asbestos-Containing 12" x 12"
Floor Tile and Mastic - Tan Flower Pattern
(HA29)**

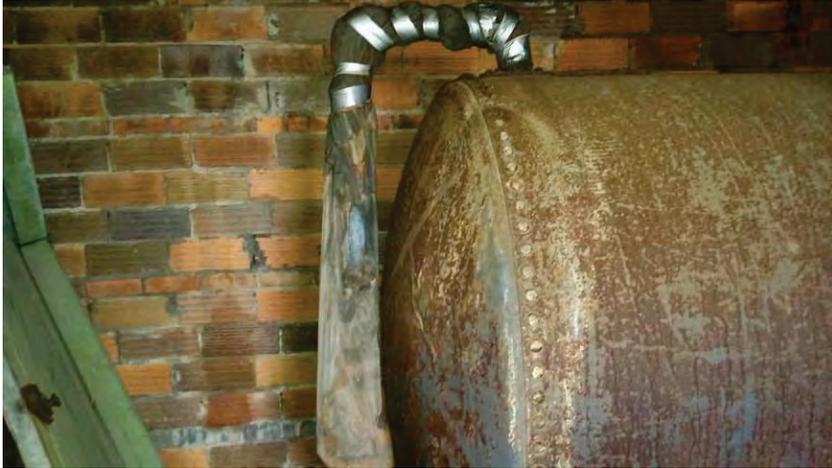
Photograph 33

View of Tan Pipe Insulation (HA32)

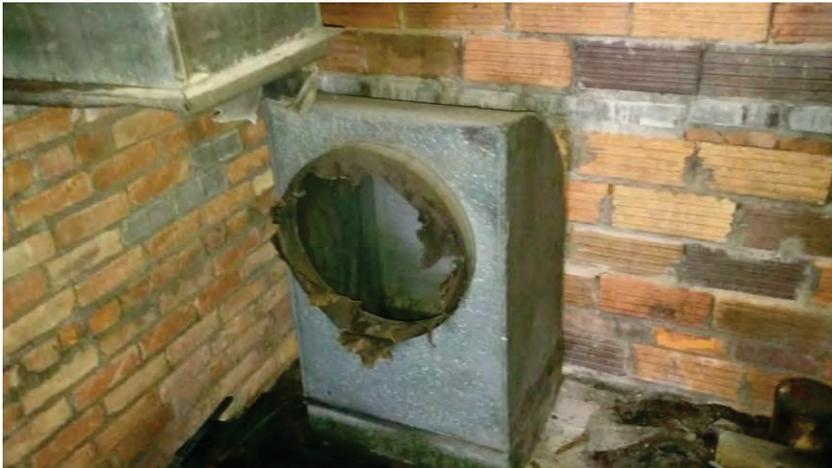
Photograph 34

View of Black Expansion Joint (HA33)

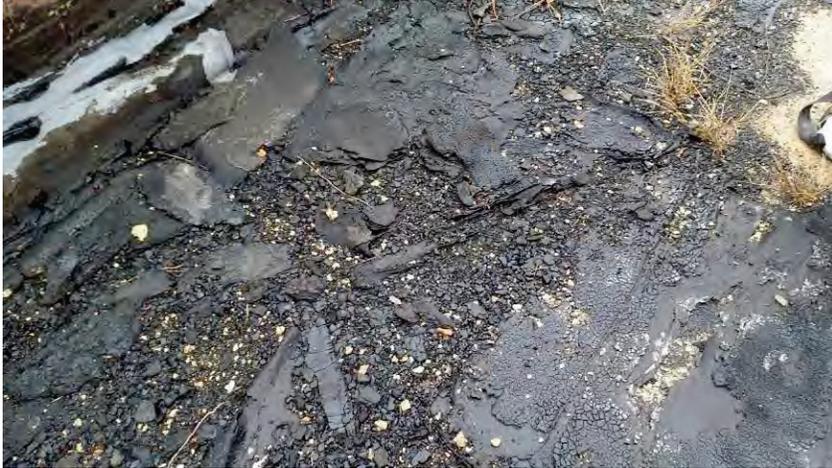
Photograph 35

View of Black Roofing Material (HA34)

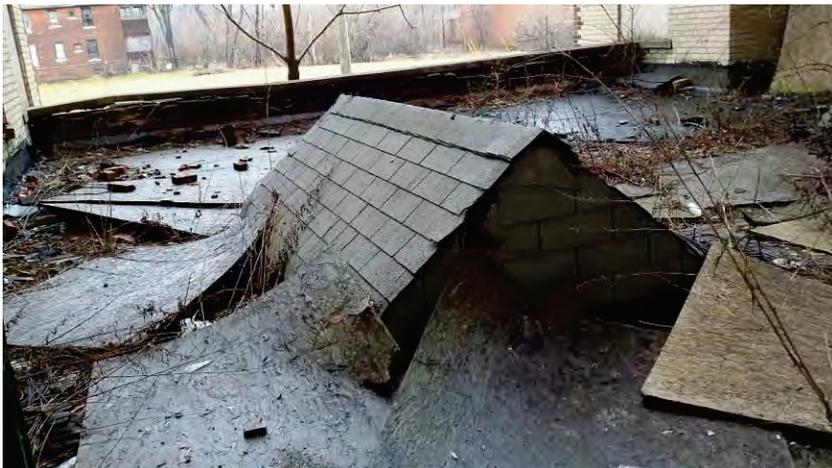
Photograph 38

View of Roofing Shingles (HA37)

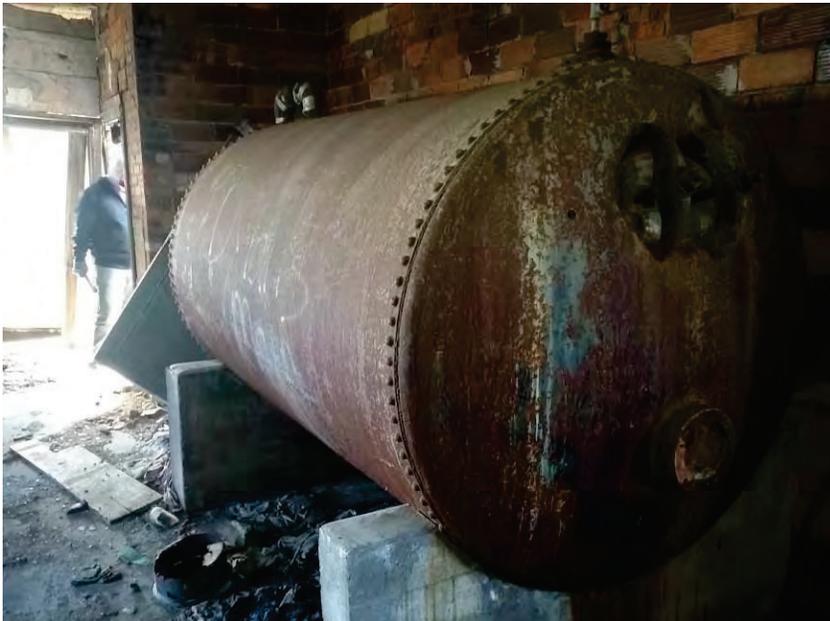
Photograph 50

View of Empty AST on 6th floor
